# **Live Load Response of Short Span Bridges with Parallam<sup>®</sup> Decks**

**A problem report submitted to  
The College of Engineering and Mineral Resources at  
West Virginia University in partial fulfillment of the  
Requirements for the degree of**

**Master of Science  
In  
Civil Engineering**

**Department of Civil and Environmental  
Engineering**

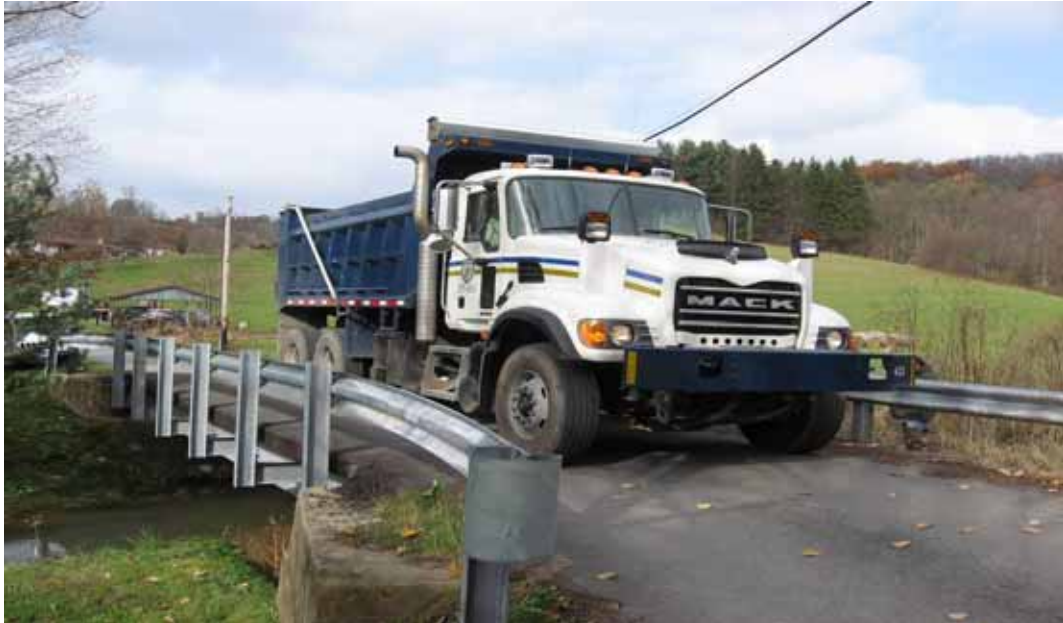
scanner. The scanner is controlled from a laptop computer. Because of the approach conditions, the test procedure was slightly different for Hackers Creek Bridge from Peel Tree Bridge testing. The response of Hackers Creek Bridge was measured with the center of gravity of the rear axle at the midspan, at 2 mph, 10 mph and 10 mph with impact. The response could not be taken at higher truck speeds because of a sharp curve at the south end of the bridge.

Figure 3.4: Static Live Load Test of Hackers Creek Bridge

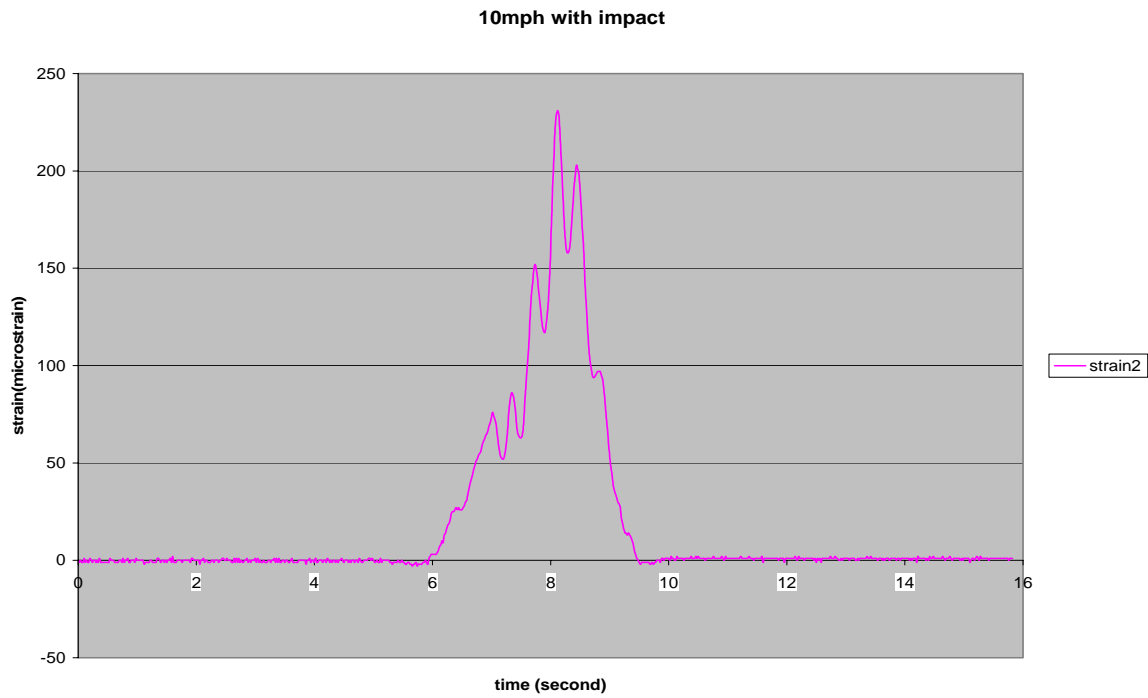
The response of Peel Tree Bridge was evaluated using the strain and deflection data. To calculate the in-service bridge response, maximum strains and deflections at each measurement location were determined. Figure 3.5 shows a typical time-strain response for one of the stringers of Peel Tree Bridge.

The maximum stringer strain recorded for Peel Tree Bridge was 302 microstrains, which is well within the yield strain of steel (2000 microstrains) and it corresponds to a stress level of 8758 psi. Also, the maximum recorded deck strain was 195 microstrains which is also well below the allowable strain (1450 microstrains) and it corresponds to a stress level of 390 psi. The maximum strain acquired during each test is reported in tables 3.1, 3.2, 3.3 and 3.4.

Figure 3.5: Strain-Time Response of Stringer 2 in Peel Tree Bridge

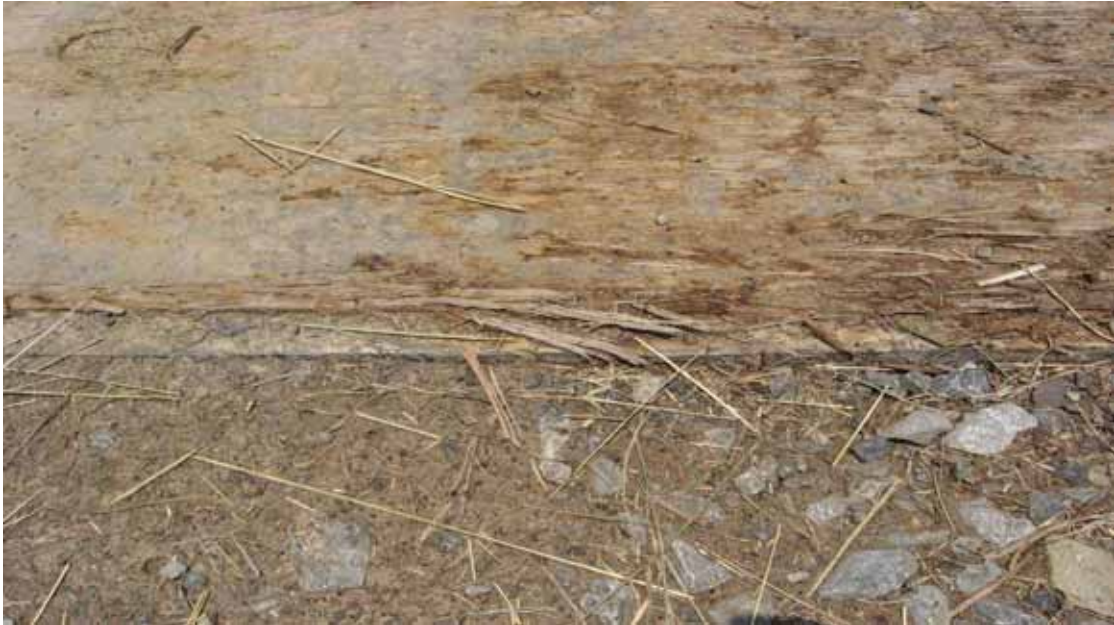
The visual inspection revealed wear and rutting of the deck in the wheel path (Figure 3.6). Also, chipping and rolling of wood fibers of the Parallam deck were noticed at the joint between the deck and the approach (Figures 3.7 and 3.8). Moreover, gravel from the roadway, driven onto the deck, has caused indentations (Figure 3.9).

Figure 3.7: Parallam Deck Chipping on Peel Tree Bridge

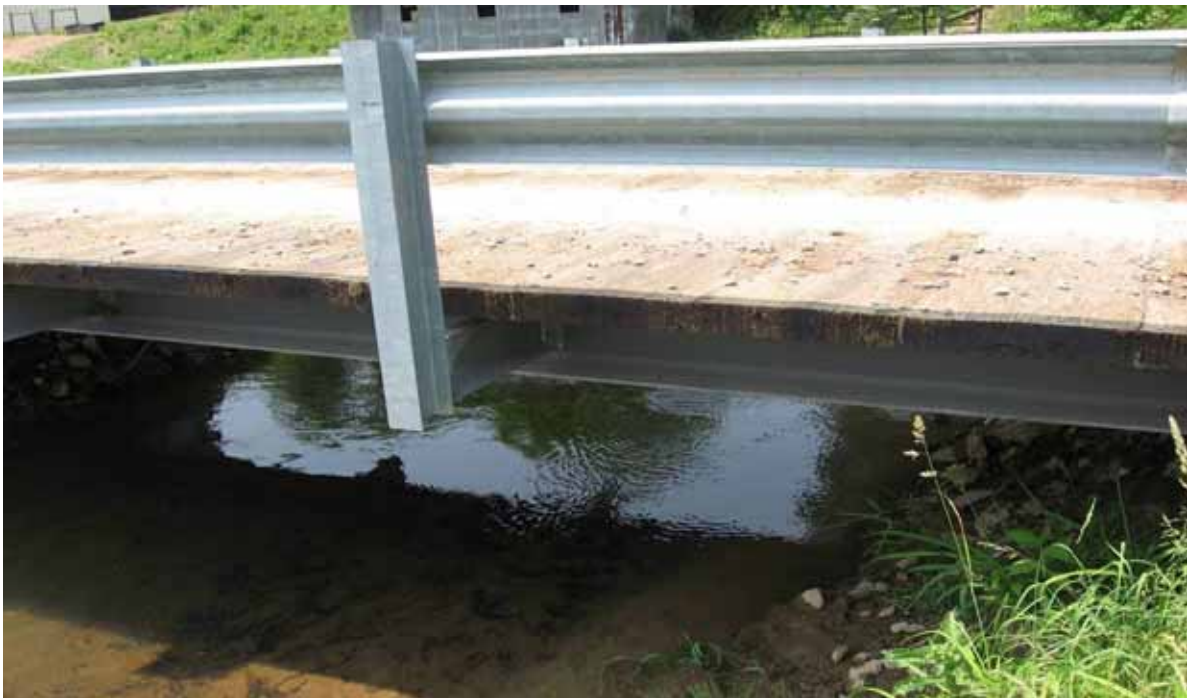
Neither the panel-to-panel connectors (i.e. the inverted channels) nor the panel-to-stringer connectors (i.e. the plate clips) showed any sign of distress. In addition, the bottom of the deck, the stringers, the guardrail and the seats are in very good condition (Figures 3.10, 3.11 and 3.12). A couple of bird nests were found on the diaphragms (Figure 3. 13).

Figure 3.10: Guardrail Condition on Peel Tree Bridge

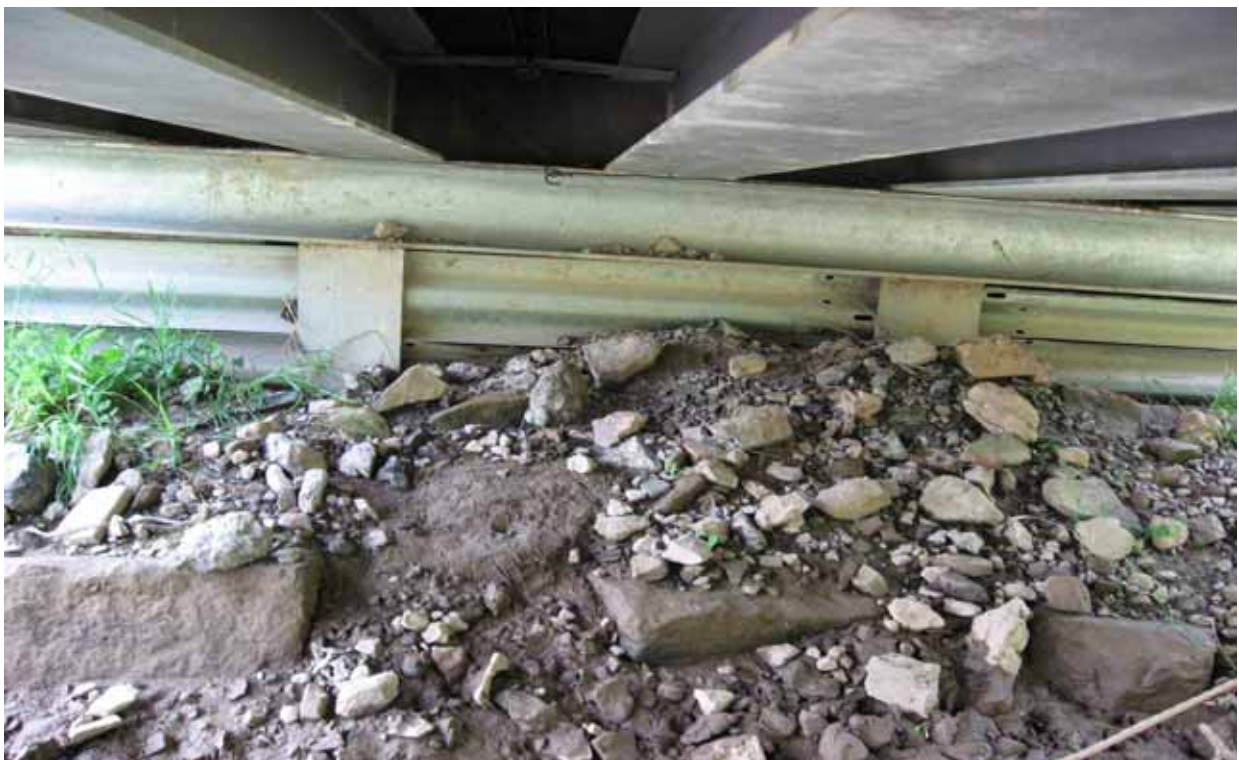
Figure 3.11: Conditions at the Bottom of Peel Tree Bridge

Figure 3.12: Conditions at the Bottom of Peel Tree Bridge

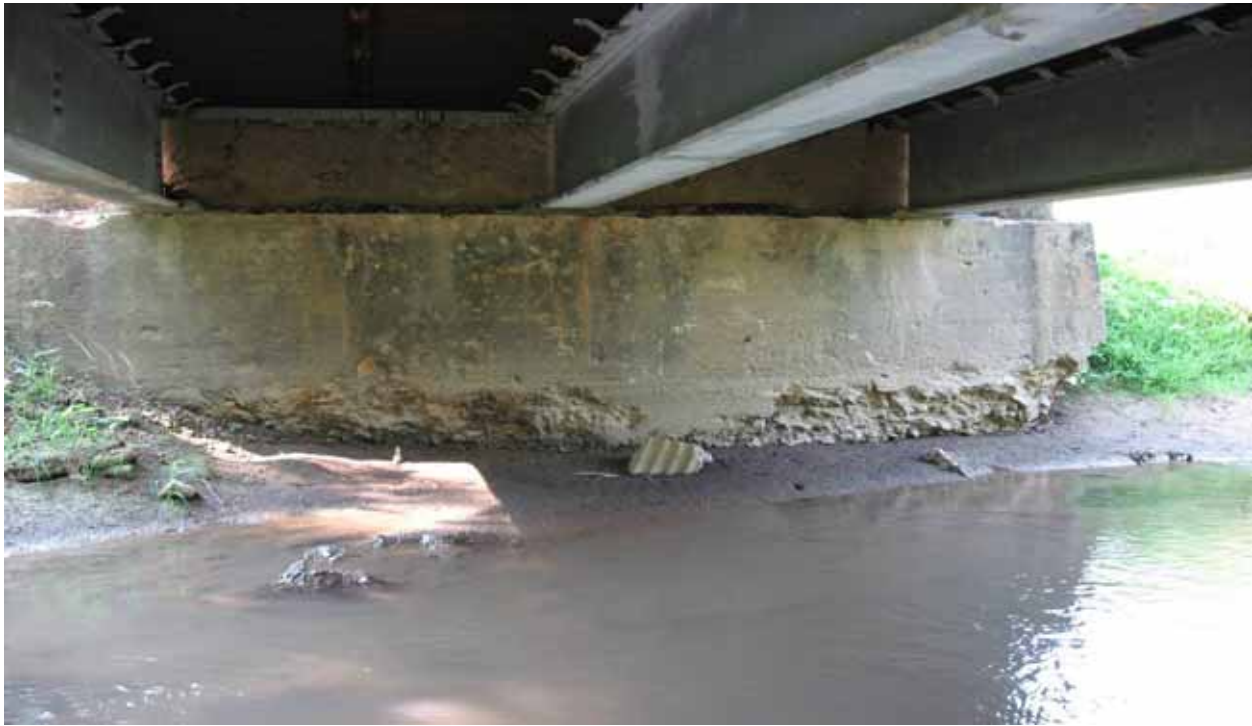
however, small dips in the wearing surface are visible (Figure 3.18). These dips coincide with the joints between the Parallam panels. Also, disintegration of abutment concrete was noticed on the north side (Figure 3.19).

Figure 3.19: Disintegration of Concrete on the north abutment
