# **Live Load Response of Short Span Bridges with Parallam<sup>®</sup> Decks**

**A problem report submitted to  
The College of Engineering and Mineral Resources at  
West Virginia University in partial fulfillment of the  
Requirements for the degree of**

**Master of Science  
In  
Civil Engineering**

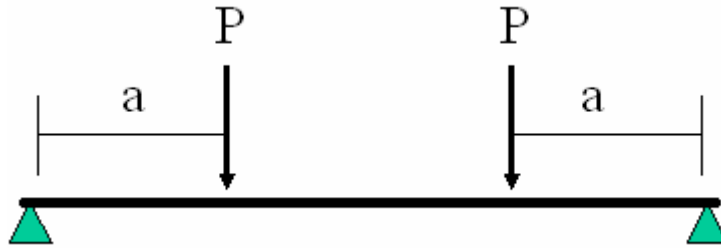
Four beams with dimensions (7"× 7" × 108") were tested under four point bending to establish the modulus of elasticity and the modulus of rupture.

Figure 2.3: Four point bending setup (smith, 2003).

The first three beams were tested in a configuration to promote a bending failure, while the fourth beam was tested in a configuration to promote shear failure. Beams 1 and 3 exhibited bending failure mode, while beams 2 and 4 exhibited horizontal shear mode. Table 2.6 shows the failure load, the maximum bending stress and the maximum shear stress for the beams.

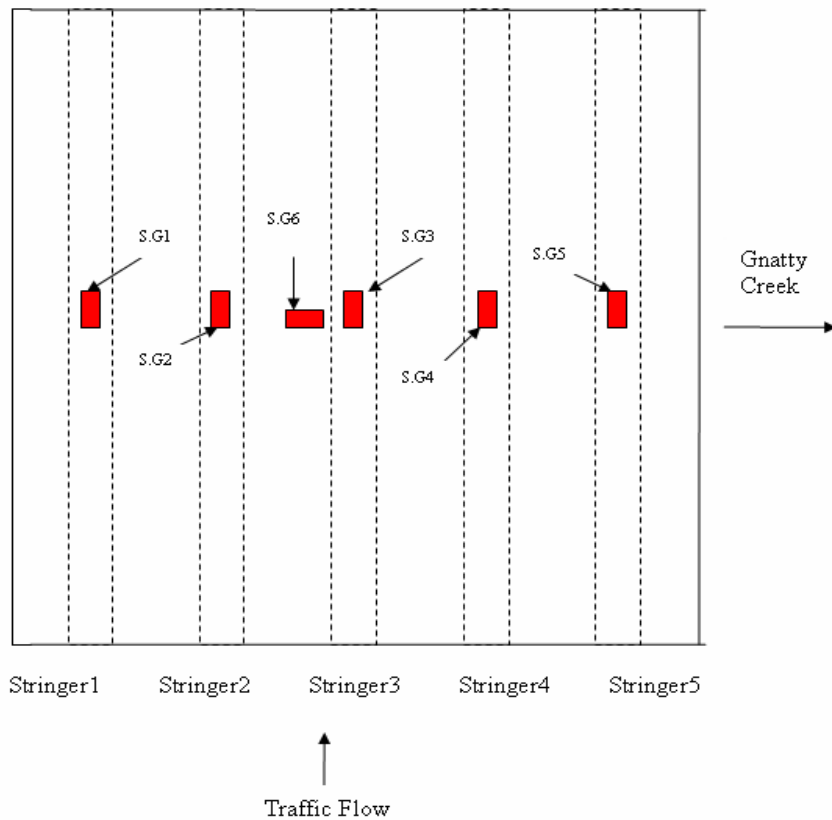
Figure 3.1 (a) and (b): Peel Tree Bridge Cross Section and Strain Gage Locations

Peel Tree Bridge is a 29 feet long span bridge located along road 20/3 in Barbour County, WV with a single traffic lane. The bridge consists of five W14×90 stringers spaced at 2'-9" centers with a 2' deck overhang. The total width of the bridge is 15'. The deck system utilized 19"×180" Parallam<sup>®</sup> panels with a deck thickness of 3.50". Plate clips are used to connect the panels and the stringers (see figure 3.11). No surface overlay was used on top of the Parallam<sup>®</sup> panels. The bridge was designed to carry a HS-25 AASHTO loading. The bridge was instrumented with five strain gages (gages 1,2,3,4 and 5) in the span direction. The gages were located at the center of the bottom flange of each steel stringer. Also, an additional strain gage (6) was installed on the bottom of the deck adjacent to the top flange of the central stringer to measure strains in the transverse direction. During the first two tests, scales were attached to stringers 1 and 3 to measure the static deflection by taking two measurements, one prior to loading and one after static loading. During the November 2006 test, two LVDTs were used to measure the static and dynamic deflections of stringers 1 and 3. For the field test in June 2007, nine LVDTs were used to measure the static and dynamic deflections of both the deck and stringers. Figure 3.1 shows a typical cross section of the bridge and strain gage locations.

(a) Peel Tree Bridge Cross Section

(b) Peel Tree Bridge Strain Gage Layout

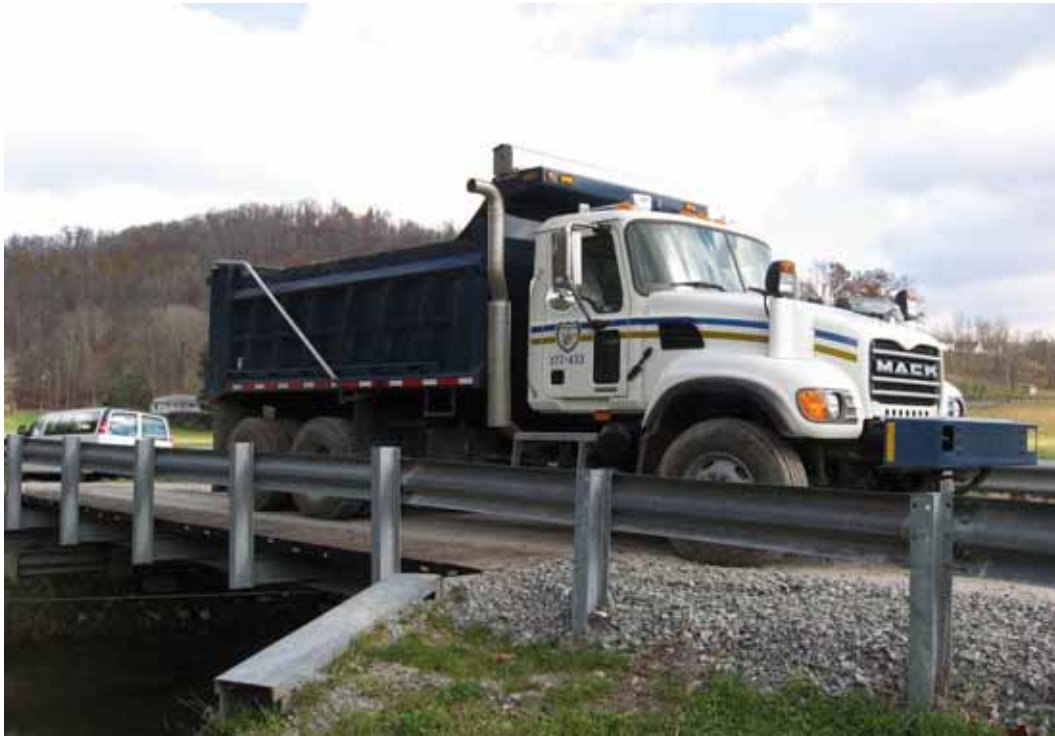
Peel Tree Bridge was tested on four separate occasions: September 2005, September 2006, November 2006 and June 2007. A dump truck provided by WVDOH passed over the bridge at different speeds: 2 mph, 10 mph and 15 mph with the exception of tests conducted in November 2006 and June 2007. During testing in November 2006 and June 2007, the truck passed over the deck at 20 mph. An additional measurement was taken at 10 mph with a 2”×4” wooden plank located just before the midspan section to represent an impact load. Also, a set of data was acquired with the center of gravity of the rear axle of the truck located at the midspan. The strain and deflection data have been acquired using a Vishay Micro-Measurements’ System 5100

Figure 3.3: Static Live Load Test of Peel Tree Bridge

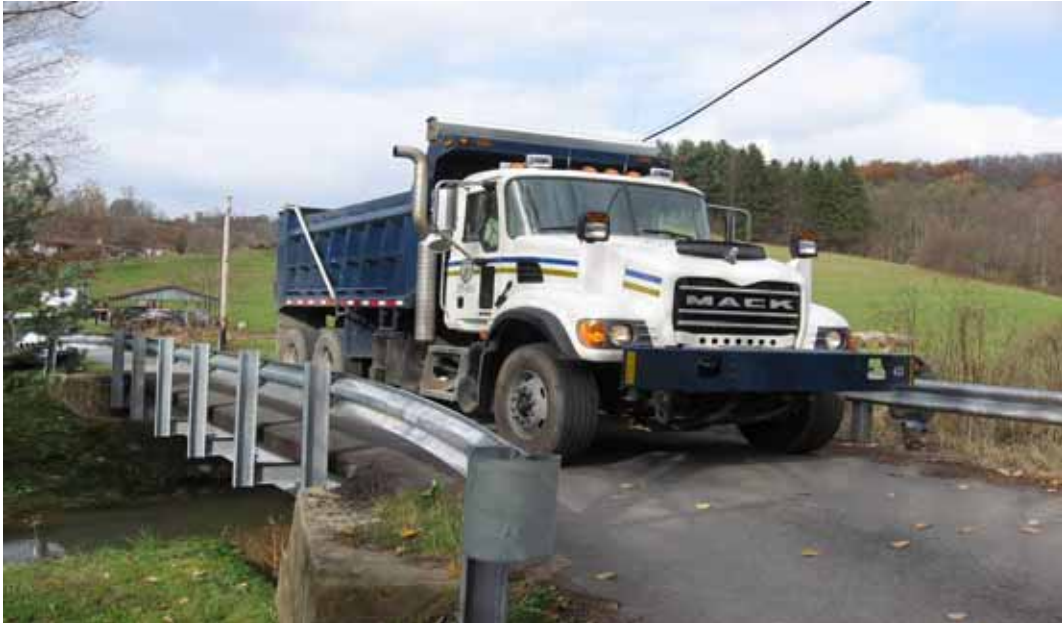
scanner. The scanner is controlled from a laptop computer. Because of the approach conditions, the test procedure was slightly different for Hackers Creek Bridge from Peel Tree Bridge testing. The response of Hackers Creek Bridge was measured with the center of gravity of the rear axle at the midspan, at 2 mph, 10 mph and 10 mph with impact. The response could not be taken at higher truck speeds because of a sharp curve at the south end of the bridge.

Figure 3.4: Static Live Load Test of Hackers Creek Bridge

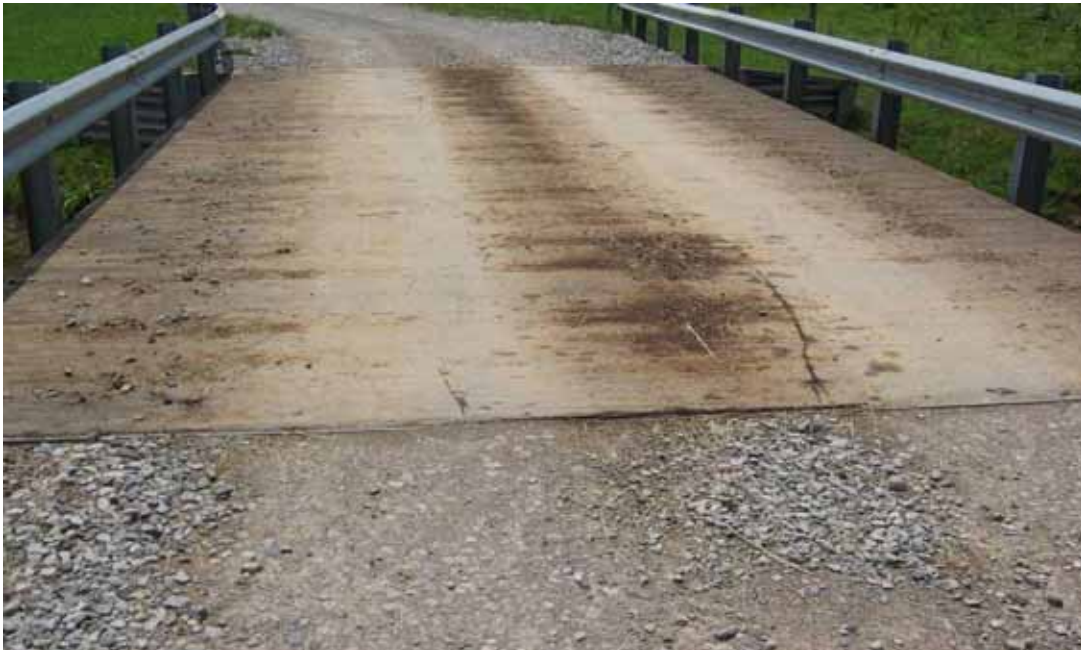
The visual inspection revealed wear and rutting of the deck in the wheel path (Figure 3.6). Also, chipping and rolling of wood fibers of the Parallam deck were noticed at the joint between the deck and the approach (Figures 3.7 and 3.8). Moreover, gravel from the roadway, driven onto the deck, has caused indentations (Figure 3.9).

Figure 3.6: Wheel Path Rutting of the Deck on Peel Tree Bridge

1. The deck of Peel Tree Bridge suffered from wear and rutting in the wheel path.
2. Gravel from the roadway has been driven onto the deck, and then embedded into the deck causing indentations.
3. Chipping and rolling of the Parallam deck was noticed between the deck and the approach.

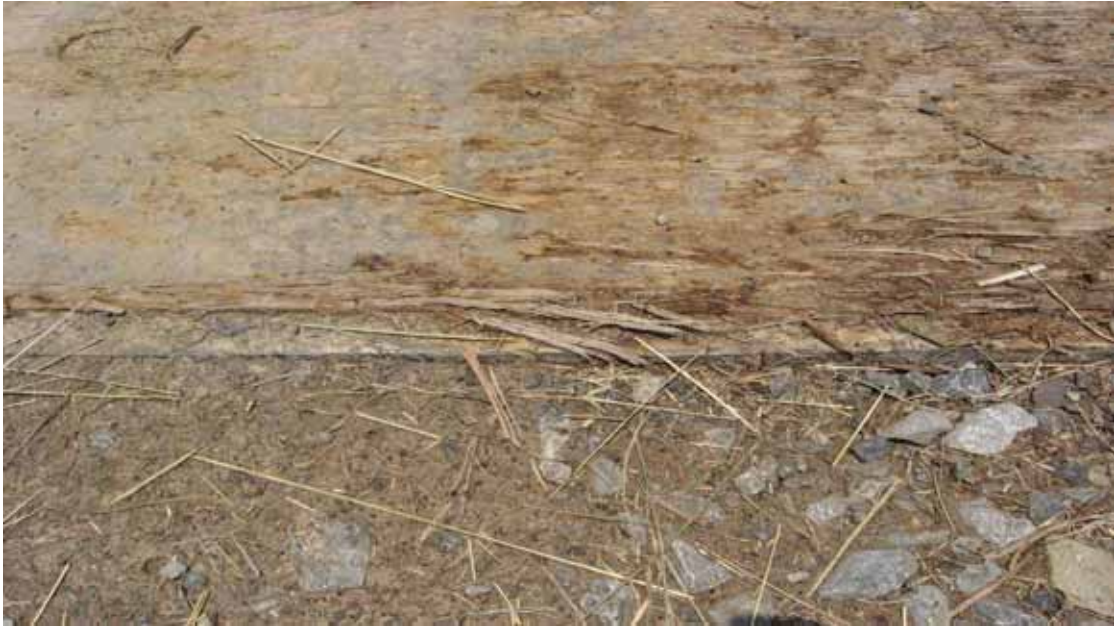
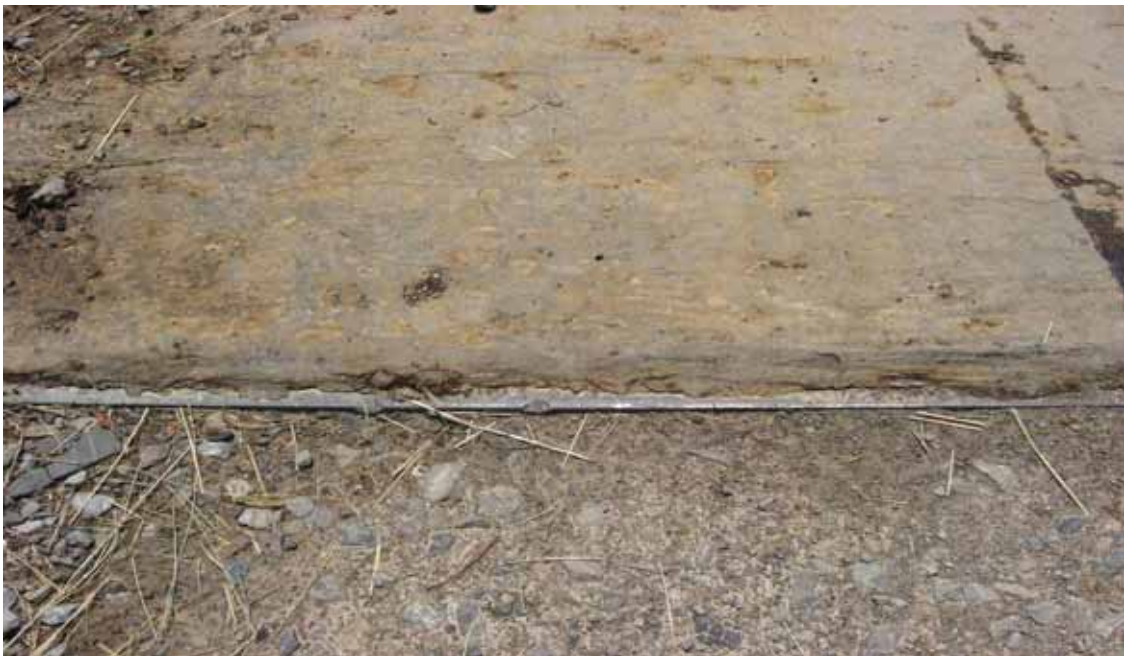
Figure 3.7: Parallam Deck Chipping on Peel Tree Bridge

Figure 3.8: Parallam Deck Rolling on Peel Tree Bridge

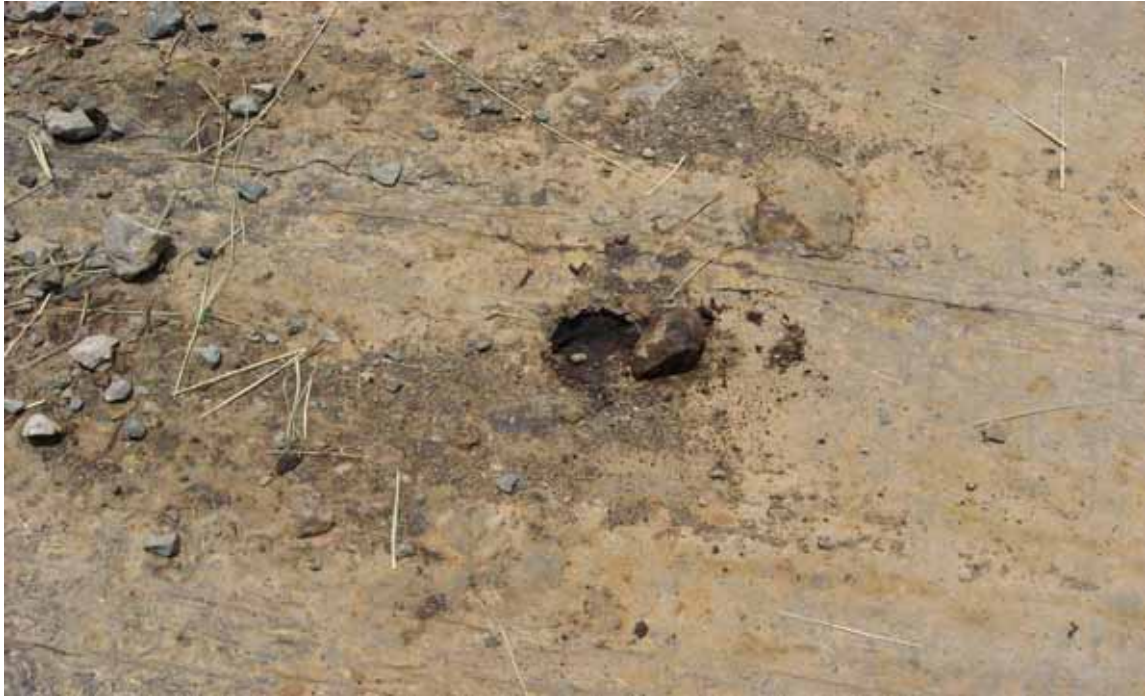
Figure 3.9: Indentation in the Deck Due to Gravel Driven in by the Traffic

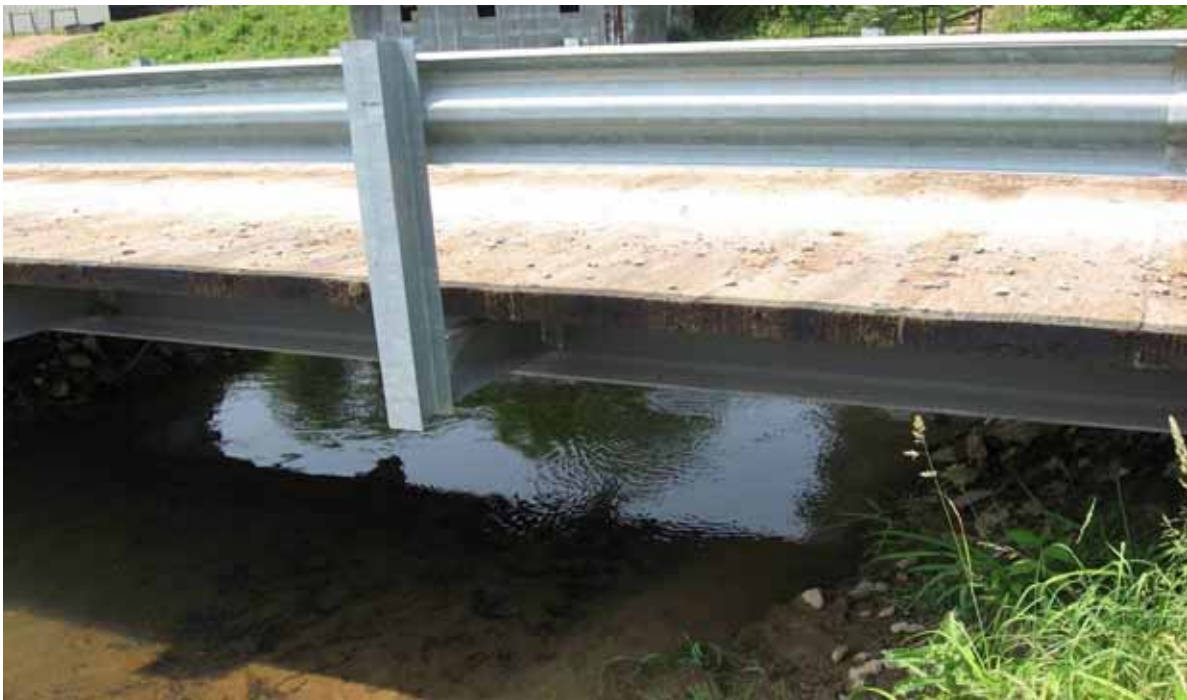
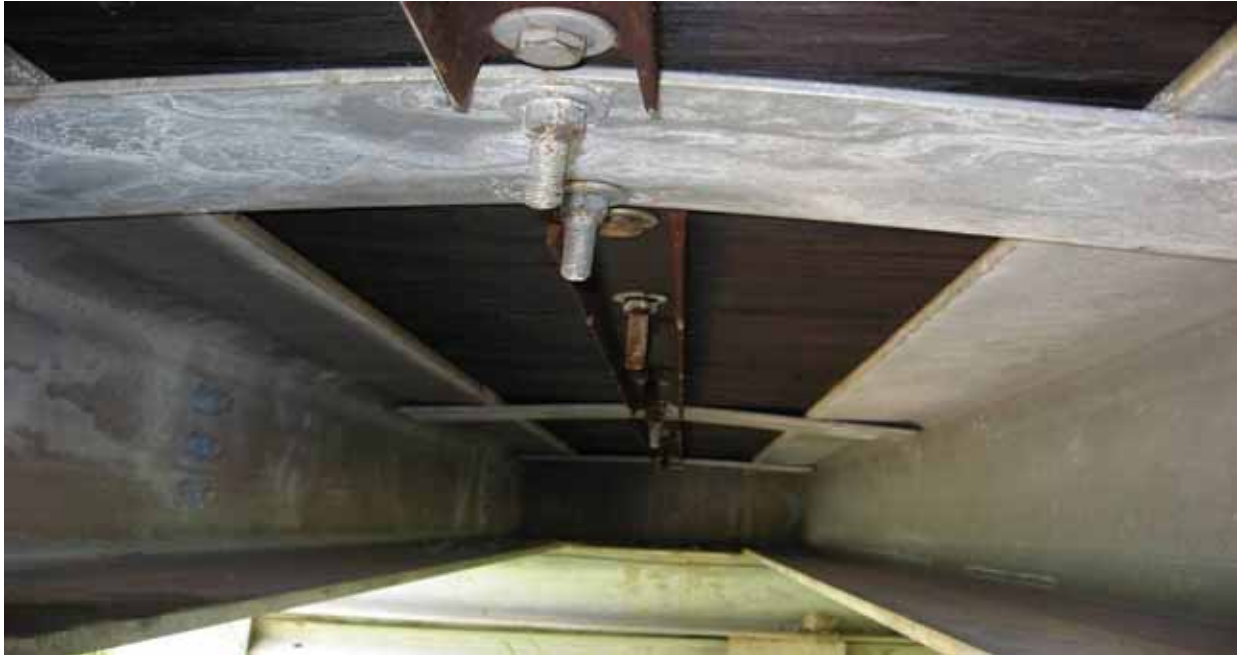
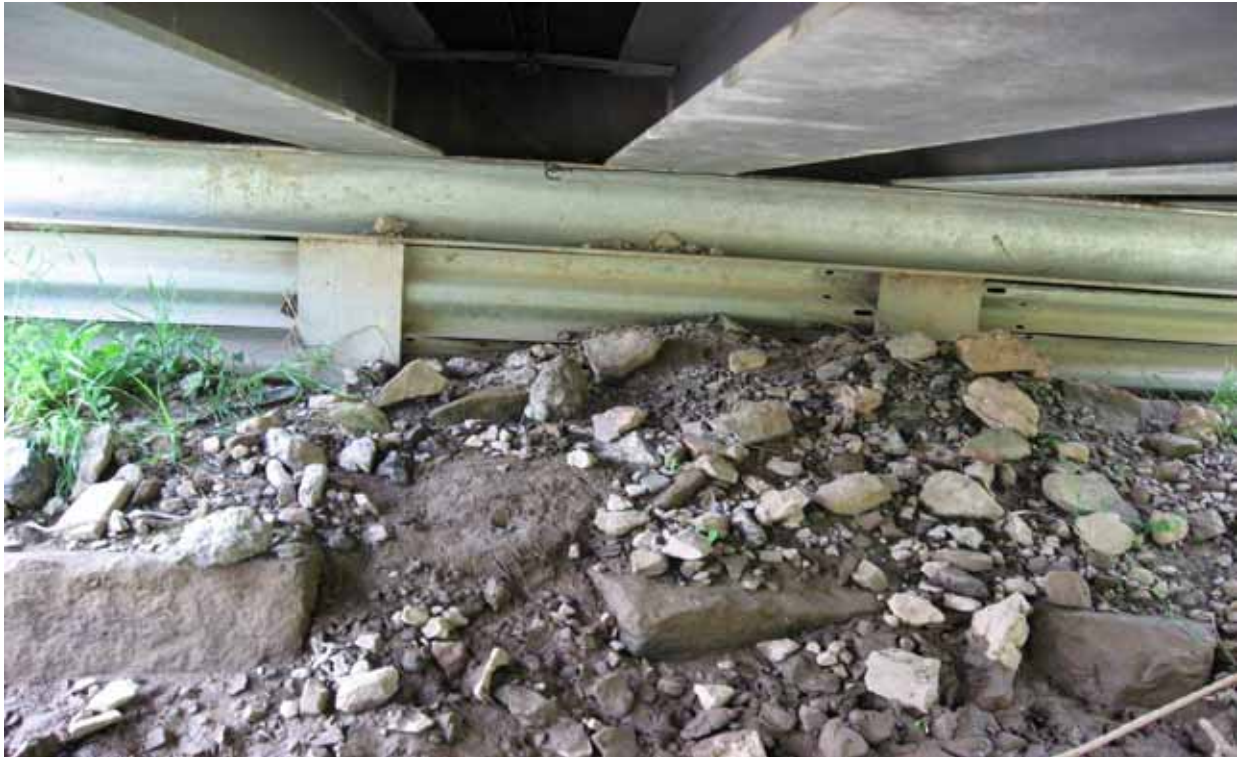
Neither the panel-to-panel connectors (i.e. the inverted channels) nor the panel-to-stringer connectors (i.e. the plate clips) showed any sign of distress. In addition, the bottom of the deck, the stringers, the guardrail and the seats are in very good condition (Figures 3.10, 3.11 and 3.12). A couple of bird nests were found on the diaphragms (Figure 3. 13).

Figure 3.10: Guardrail Condition on Peel Tree Bridge

Figure 3.11: Conditions at the Bottom of Peel Tree Bridge

Figure 3.12: Conditions at the Bottom of Peel Tree Bridge

4. The bottom of the deck, the deck-to-stringer connectors, the panel joiners, the guardrail and the seats are in very good condition.
5. The average moisture content of the deck was below the 19% limit set by AASHTO bridge design specifications.
6. The deck creep is virtually zero.

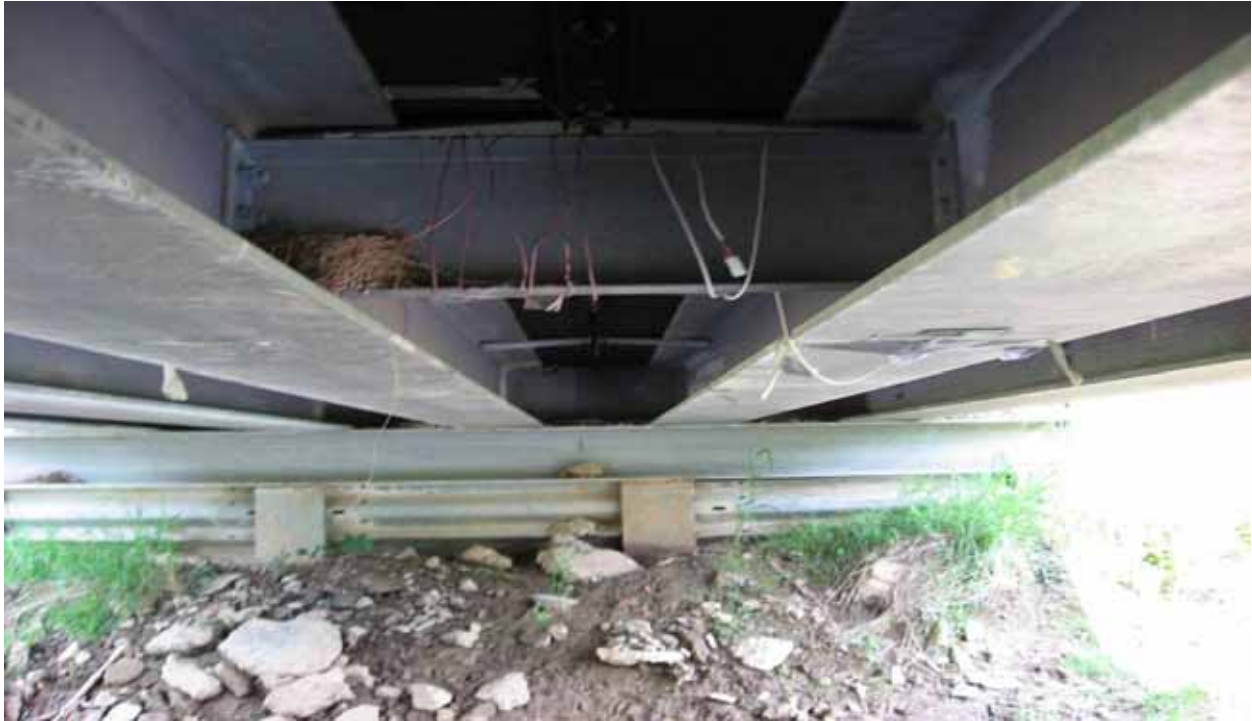
Figure 3.13: Bird Nest on the Diaphragm

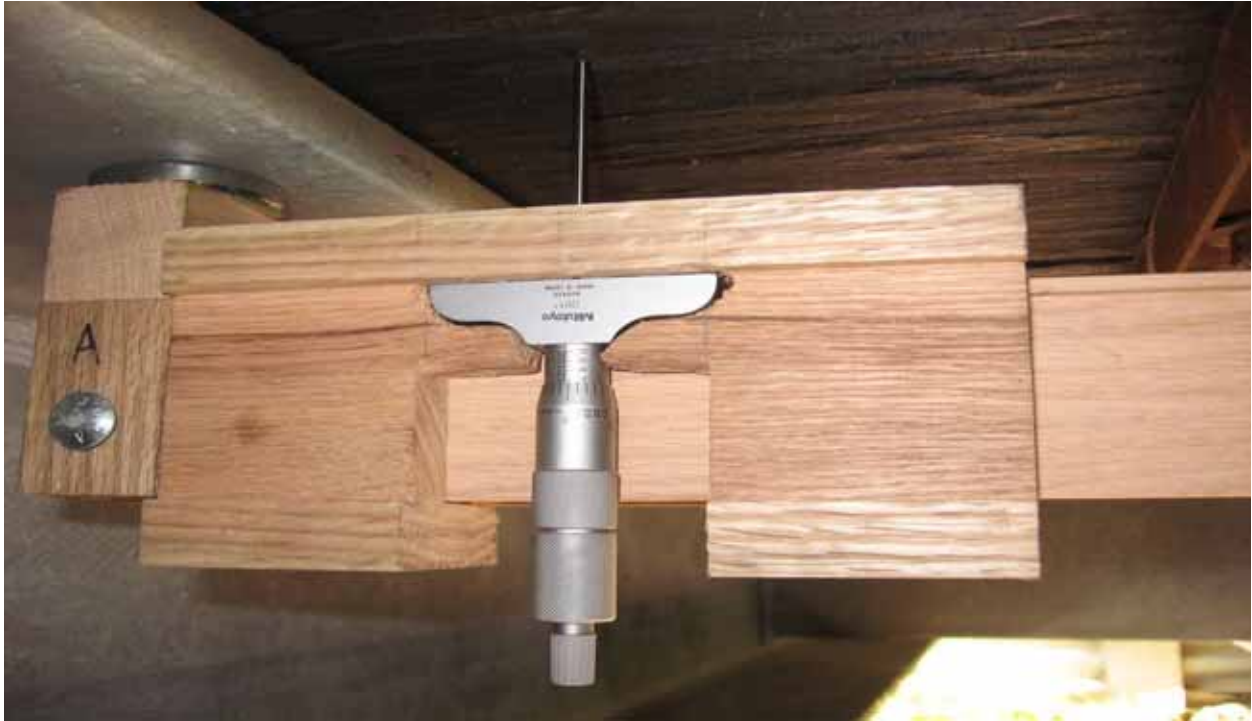
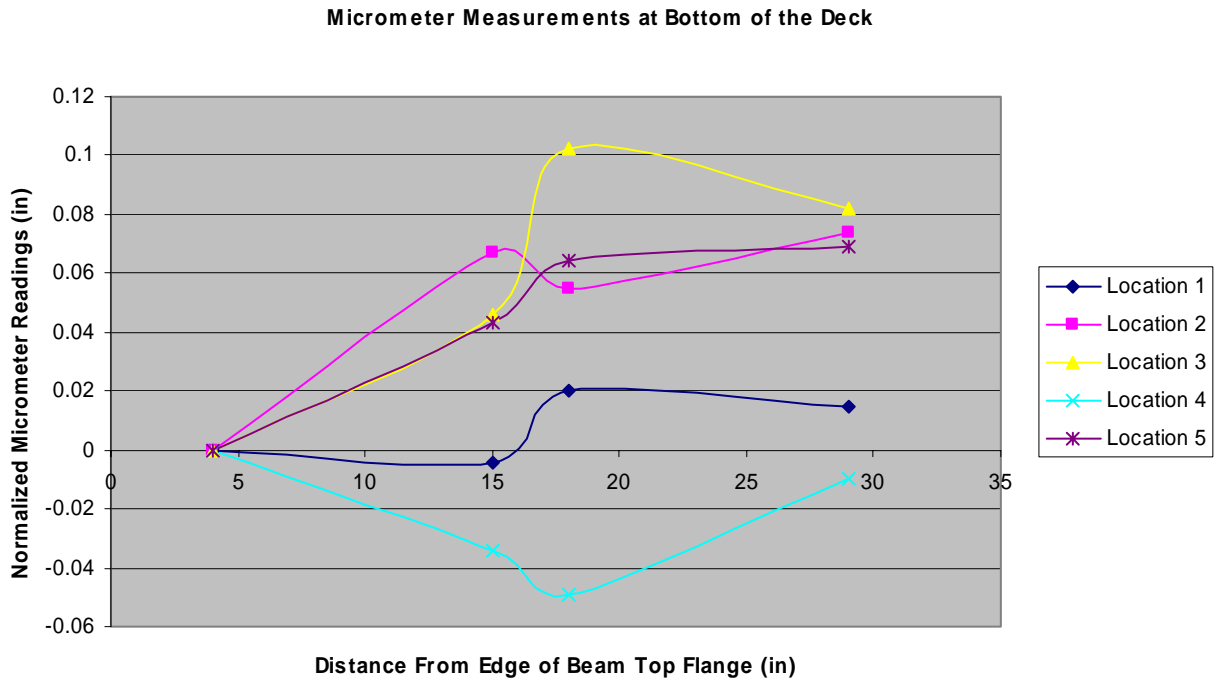
In an attempt to measure deck creep, a micrometer has been used to measure the elevations at four locations in the bottom of the deck between the top flanges of the stringers (see Figure 3.14). Four discrete measurement points were taken: at 4" and at 29" from the edge of the top flange and to the left and to the right of the inverted channel. The maximum difference in elevation was about 1/8" which suggests that the creep is virtually zero (Figure 3.15). There is sudden change in the slope of the lines to the left and right of the channel. A possible explanation is that one side of the inverted channel dug into the deck while tightening the bolts. It should be noted that the points on the positive side of the Y axis of Figure 3.15 indicate camber (upward) while the points on the negative side indicate a downward deflection.

Figure 3.14: Using the Micrometer to Take Creep Measurements

Figure 3.15: Normalized Micrometer Readings at the Bottom of the Deck

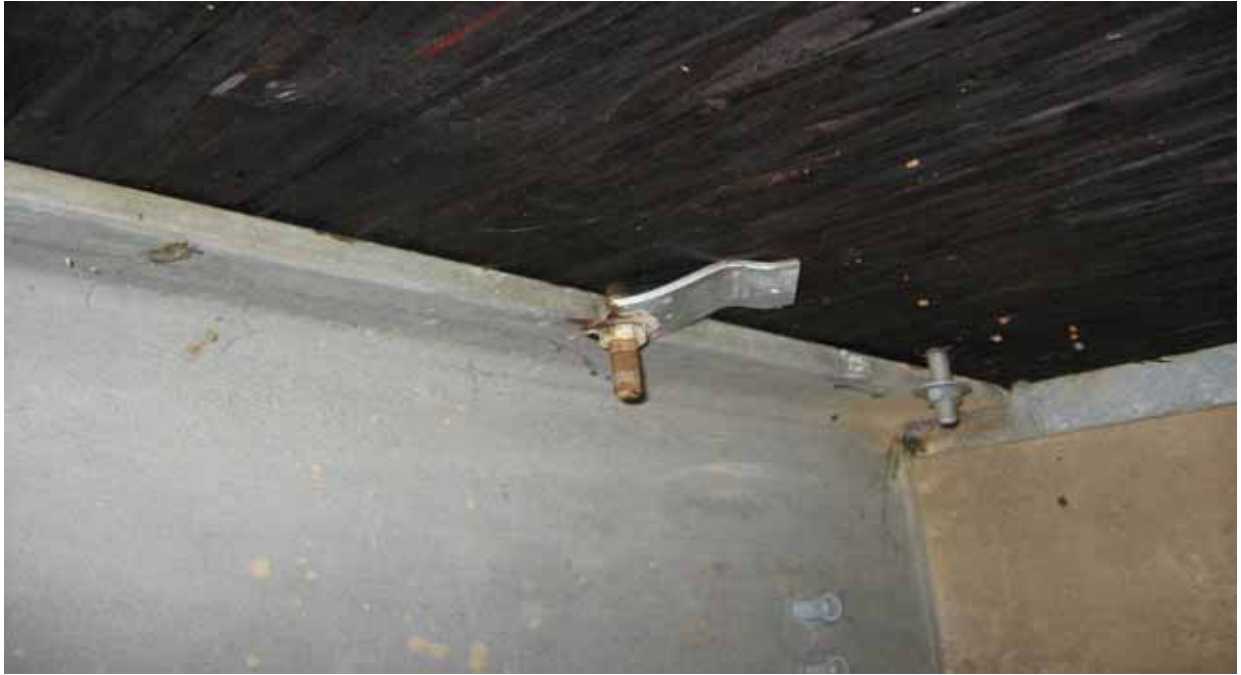
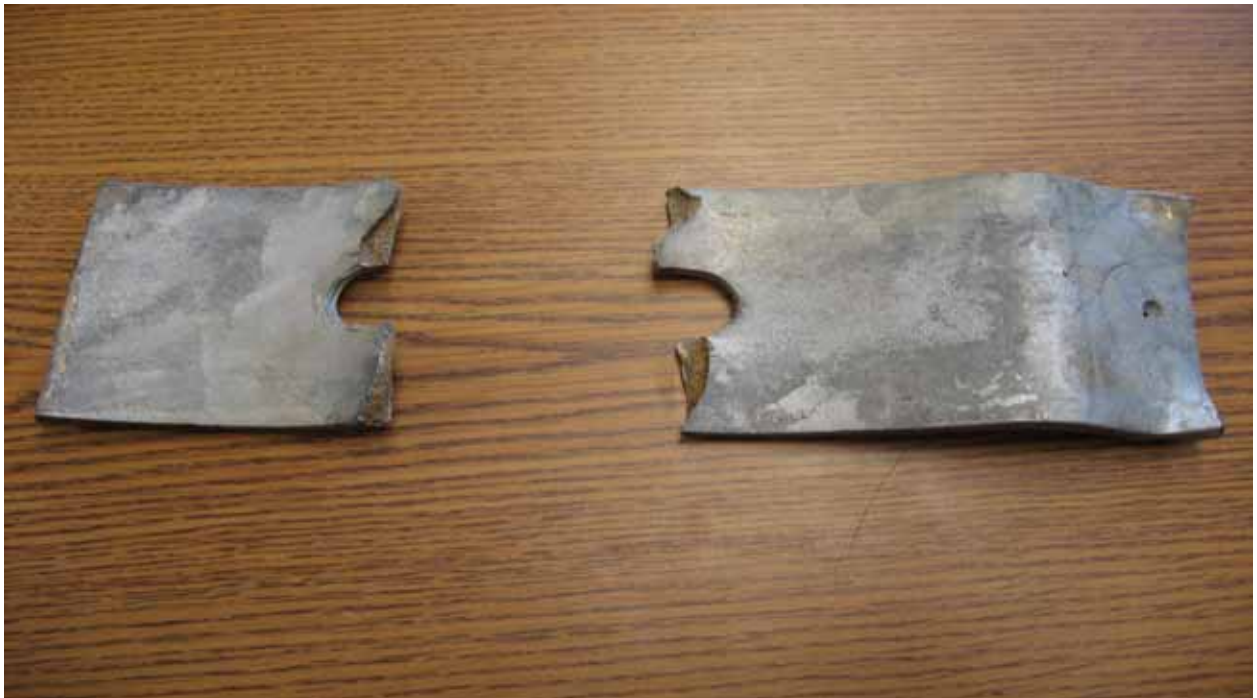
The inspection also revealed the stringer-to-panel connector failure. These connectors exhibited a brittle mode of failure at the bolt location as seen in Figures 3.16 and 3.17. This failure could be due to one or a combination of the following factors: 1) the connectors were over stressed due to excessive torque on the bolts, 2) hydrogen embrittlement during galvanization process, 3) manufacturing faults, and 4) excess traffic induced fatigue stresses. At least nine connectors were broken or missing.

Figure 3.16: A Failed Stringer to Deck Connector on Hackers Creek Bridge

Figure 3.17: Failure Mode of a Stringer to Deck Connector on Hackers Creek Bridge

1. The bottom of the deck was in a very good condition.
2. Vertical movement of the deck panels relative to one another was observed under traffic load.
3. Nine deck-to-stringer spring connectors failed at the bolt locations in Hackers Creek Bridge and the mode of failure was brittle.
4. The wearing surface showed no signs of reflective cracking, however, small dips were noticed in the wearing surface that coincide with the deck panels joint locations.
5. The average moisture content of the deck was within the permissible limit of 19%.
6. The creep of the deck panel is close to zero.

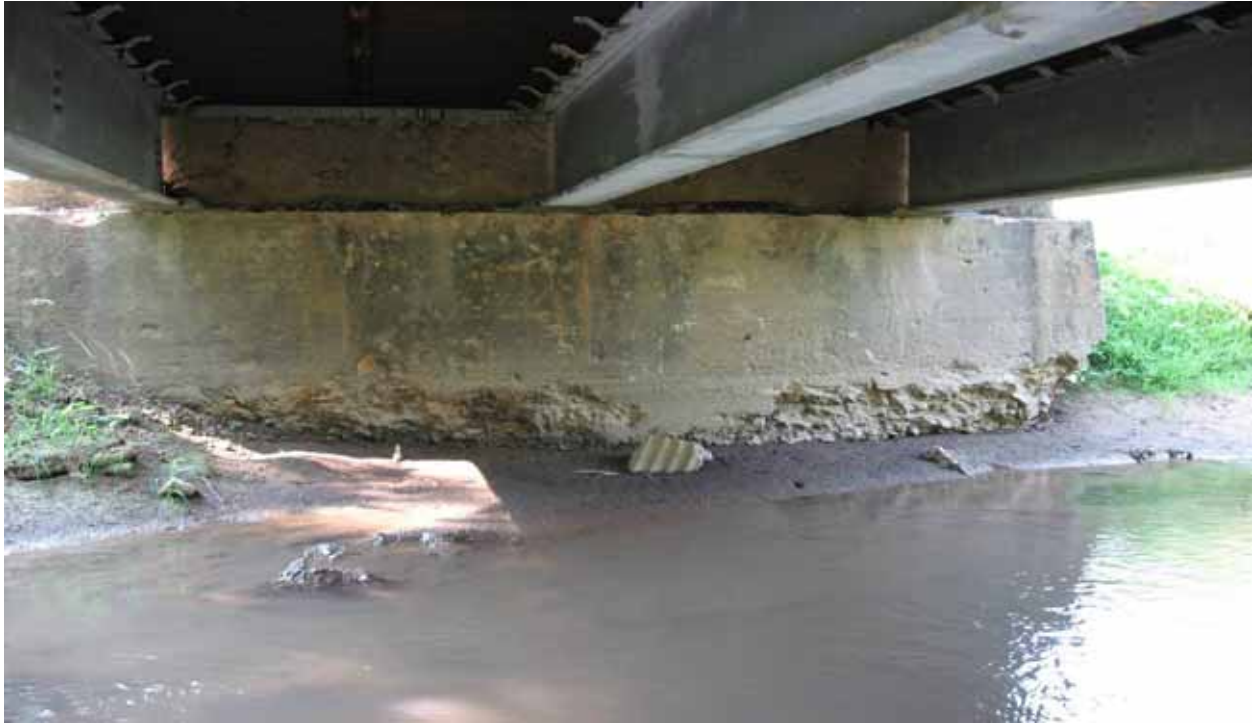
however, small dips in the wearing surface are visible (Figure 3.18). These dips coincide with the joints between the Parallam panels. Also, disintegration of abutment concrete was noticed on the north side (Figure 3.19).

Figure 3.19: Disintegration of Concrete on the north abutment

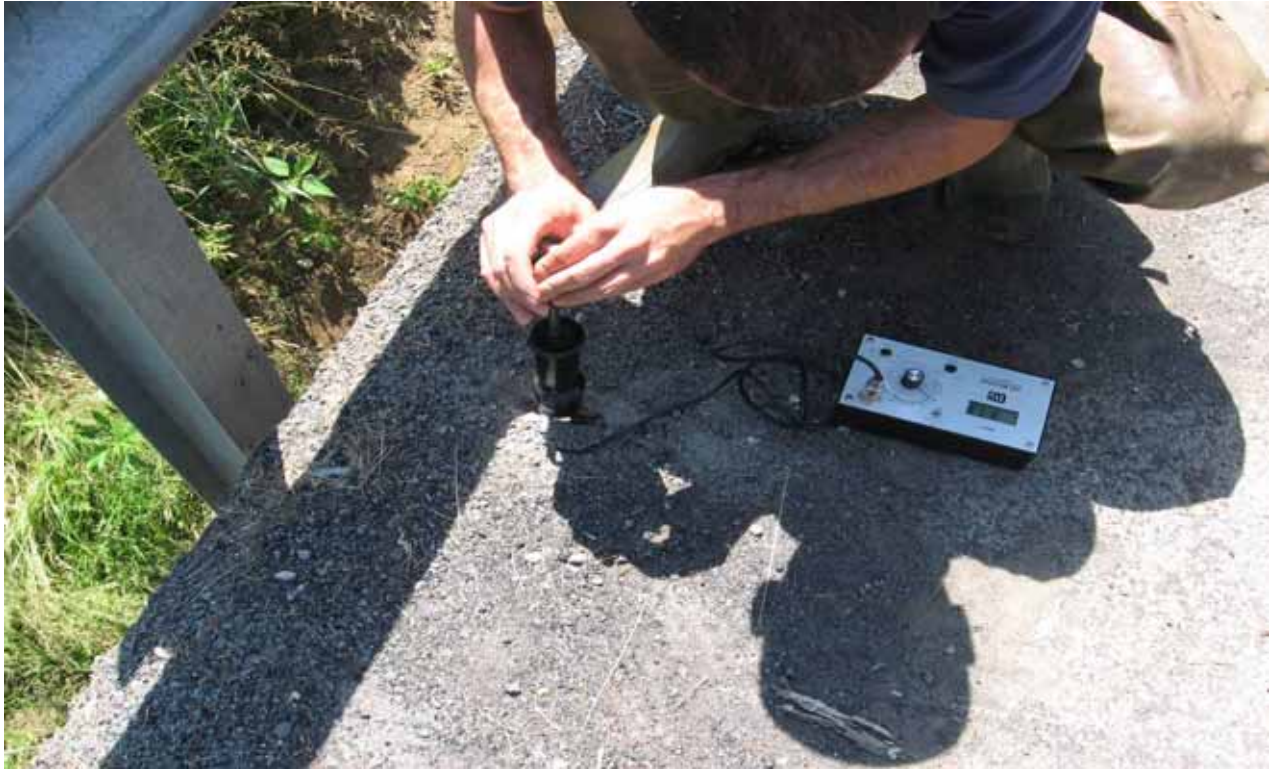
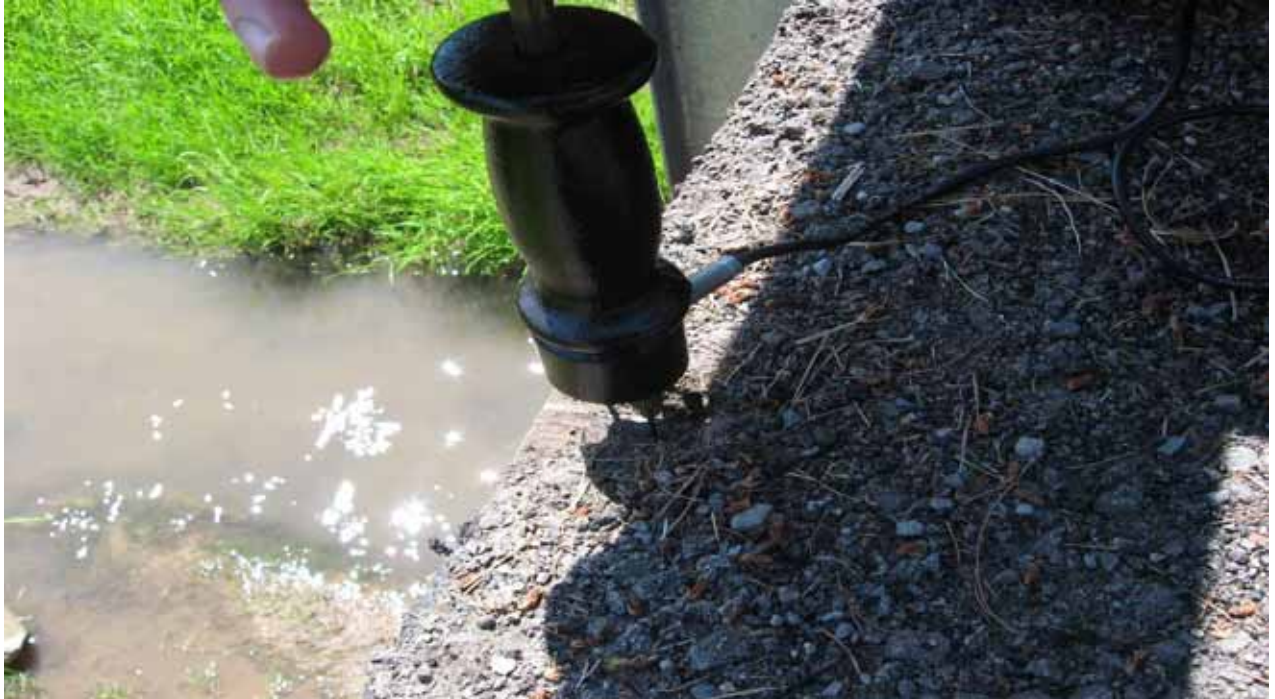
Moisture content measurements were taken at both the top and bottom surfaces of the deck. Ten measurements were taken on the top of the deck and the average moisture content was 10.88%. Also, ten readings were taken at the bottom of the deck and the average moisture content was 12.94% (see Figures 3.20 & 3.21). The average moisture content is below the maximum specified by AASHTO bridge design specifications (LRFD and standard) which is 19%.

Figure 3.20: Taking Deck Moisture Content Readings on Hackers Creek Bridge

Figure 3.21: Taking Deck Moisture Content Readings on Hackers Creek Bridge

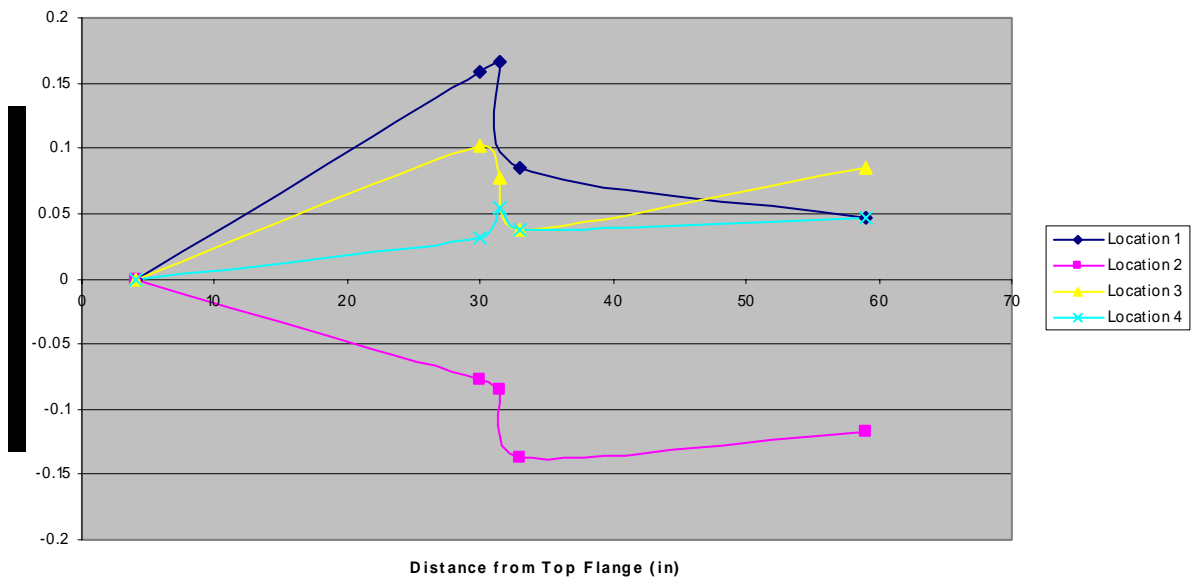
A micrometer was used to detect any creep in the Parallam deck between stringers. The procedure to measure creep is similar to the description given earlier for Peel Tree Bridge. Again, the differences in the micrometer measurements were less than 1/8", which indicates that deck creep deformations are close to zero. There is sudden change in the slope of the lines to the left and right of the channel. A possible explanation is that one side of the inverted channel dug into the deck while tightening the bolts. It should be noted that the points on the positive side of the Y axis of Figure 3.22 camber, while the points on the negative side indicate deflection.

Figure 3.22: Normalized Micrometer Measurements at the Bottom of the Deck
