Live Load Response of Short Span Bridges with Parallam® Decks

A problem report submitted to
The College of Engineering and Mineral Resources at
West Virginia University in partial fulfillment of the
Requirements for the degree of

Master of Science
In
Civil Engineering

Abstract
Live Load Response of Short Span Bridges with Parallam® Decks

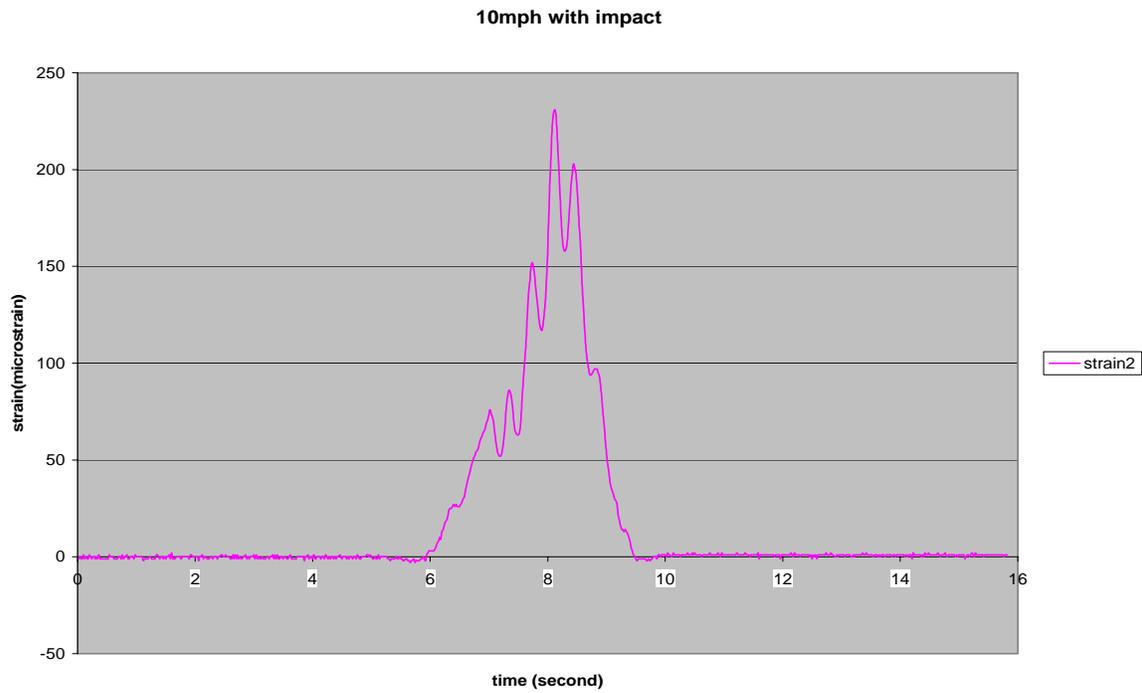
Figure 3.5: Strain-Time Response of Stringer 2 in Peel Tree Bridge

The maximum stringer strain recorded for Peel Tree Bridge was 302 microstrains, which is well within the yield strain of steel (2000 microstrains) and it corresponds to a stress level of 8758 psi. Also, the maximum recorded deck strain was 195 microstrains which is also well below the allowable strain (1450 microstrains) and it corresponds to a stress level of 390 psi. The maximum strain acquired during each test is reported in tables 3.1, 3.2, 3.3 and 3.4.
